2033 Gateway Place Suite 500, San Jose, CA 95110
Inspection prepared for: Wall 2 Wall
Date of Inspection: 1/1/2015 Time: 8:30 AM
Age of Home: 2009 Size: 2170
Weather: Sunny
Sample Report

Report Summary

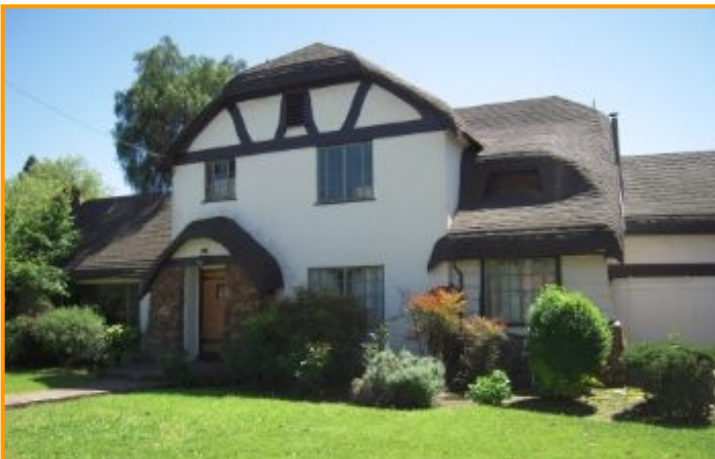
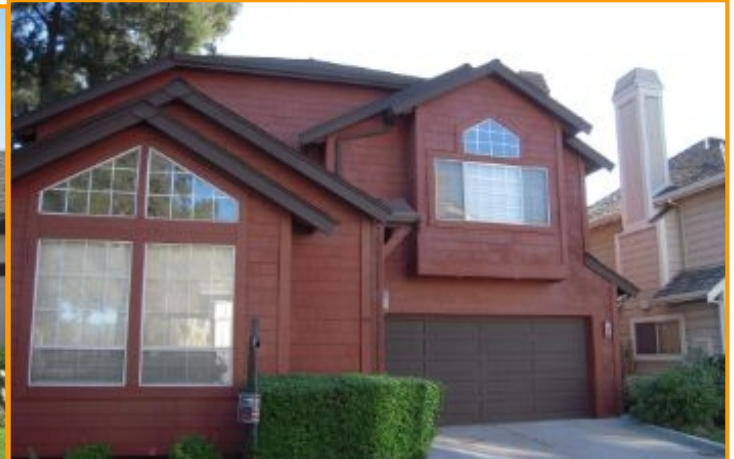
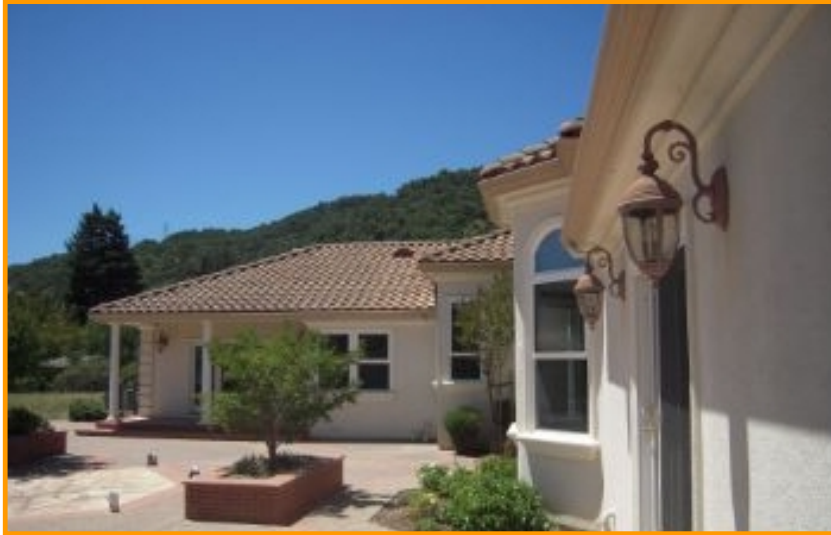
- **Monitor: Common minor cracks were observed on the exterior walls of the house. The location, size, shape of these cracks is common. The inspection did not find evidence of significant movement requiring immediate major repairs.**

Monitor: Common minor cracks were observed on the exterior walls of the house. The location, size, shape of these cracks is common. The inspection did not find evidence of significant movement requiring immediate major repairs.

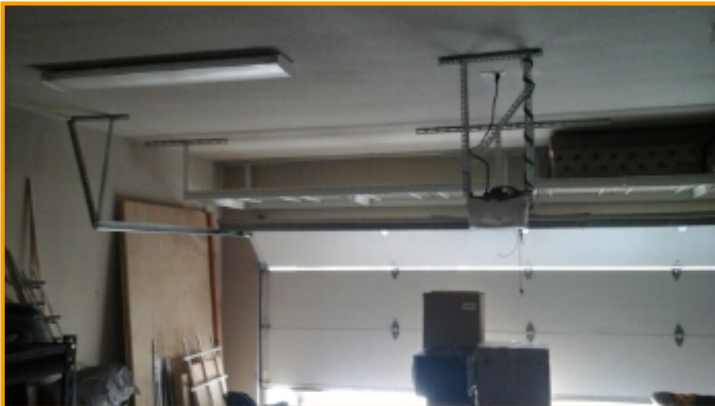
Repair: The garage door opener was not functioning, owner had adjusted to stay partially open. Verify garage door is operating. It should be repaired as necessary.

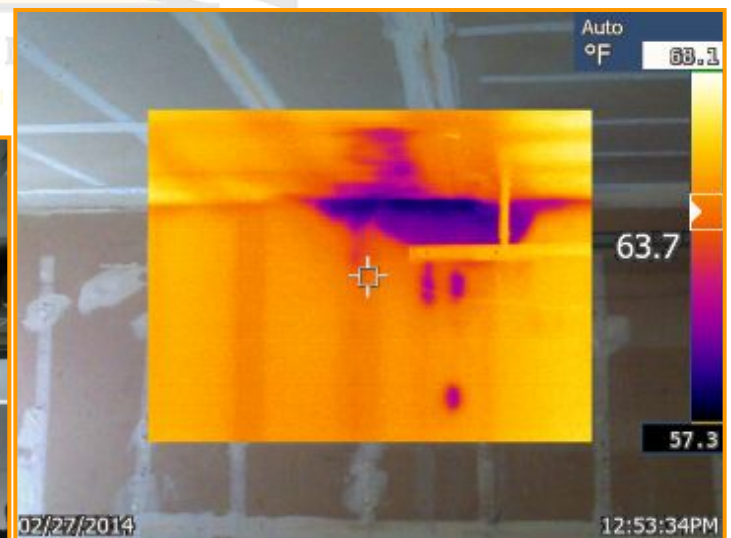
Garage wall under bathroom showing signs of moisture. This appears to be coming from a toilet located above garage, recommend fixing waste pipe to prevent water/moisture damage.

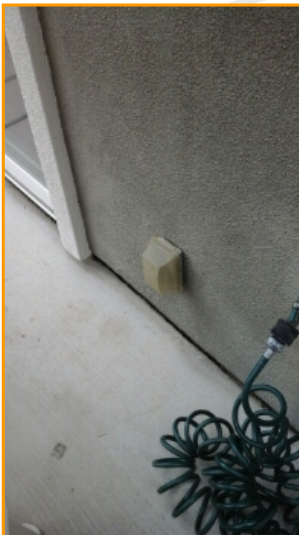
Repair: A ground fault circuit interrupter (GFCI) outlet is inoperative. This circuit should be repaired. Outside rear sliding glass door.

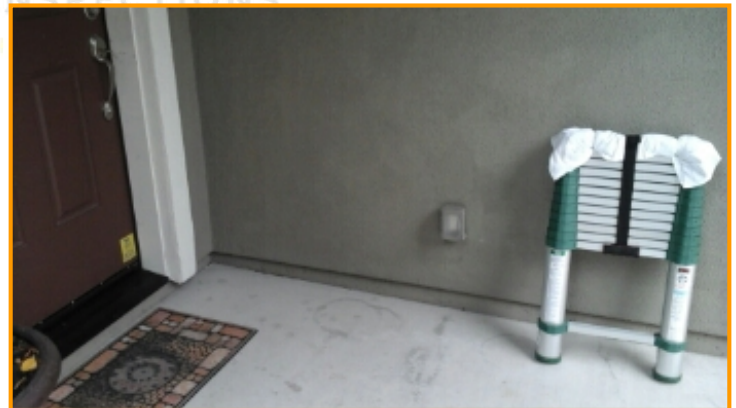
Safety Issue: The installation of a ground fault circuit interrupter (GFCI) is recommended. A GFCI offers increased protection from shock or electrocution. Outside front door

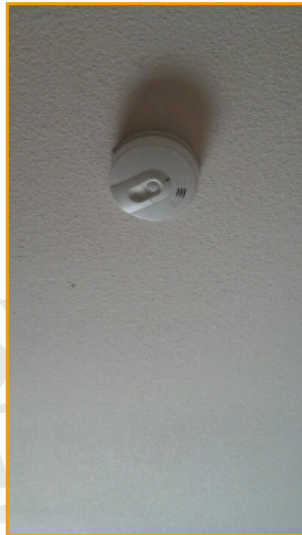
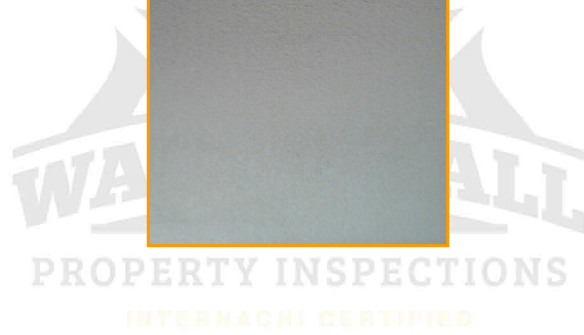
- **Smoke detectors did operate as intended when button was pushed.**
- **Repair, Safety Issue:** No carbon monoxide detector upstairs, recommend installing CO monitor in hallway in between all bedrooms upstairs.

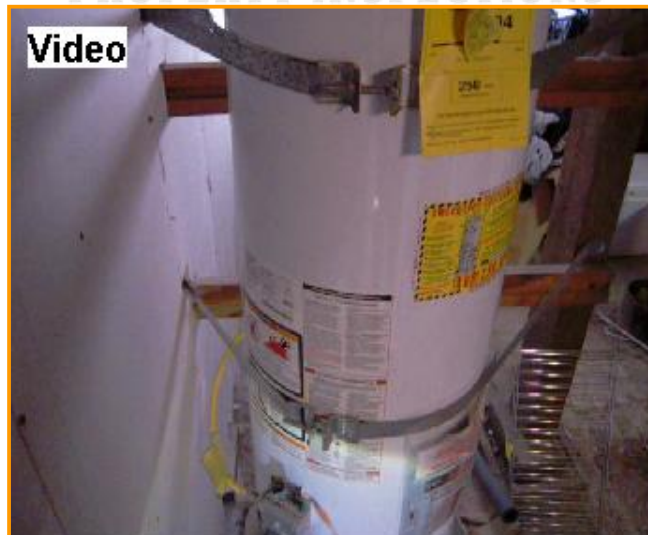
- **Repair, Safety Issue:** For safety reasons, it is recommended that a Temperature and Pressure Relief (TPR) Valve be installed for the water heater. The lack of such a valve is a safety concern.
- **Repair, Safety Issue:** The “draft diverter” of the water heater venting system is configured in such a way that it could allow spillage of exhaust products. This is a potential safety concern that should be addressed promptly.

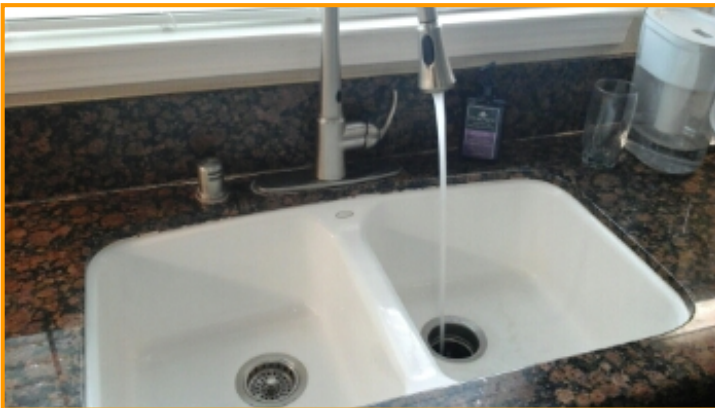
Improve: The kitchen faucet is loose.

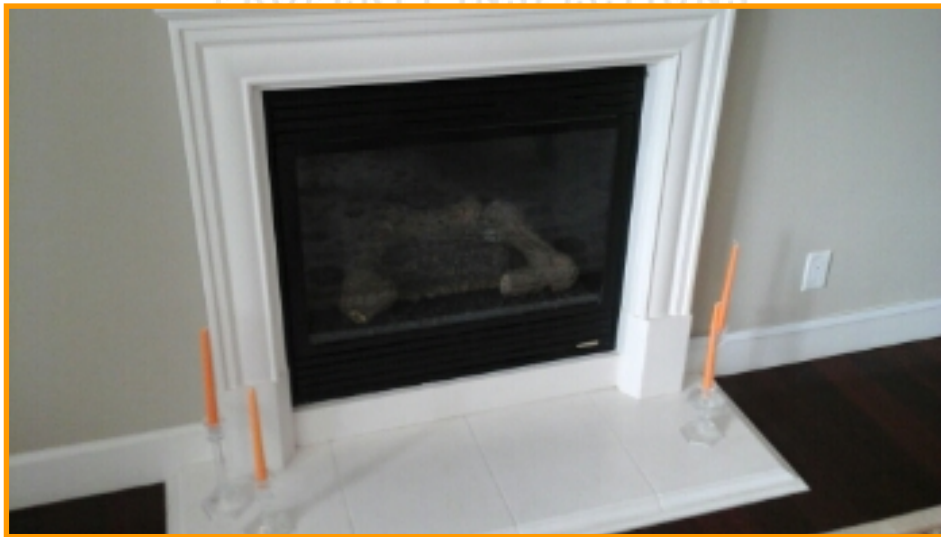
- **Repair: The fireplace was not working at time of inspection.**

Repair: The fireplace was not working at time of inspection.
